# Selling Arguments *for* TIN ROOFING

*A review of the advantages of  
roofs of this type*

A textbook containing corrected tables for use in estimating, instructions for laying tin roofs, description of the manufacture of roofing tin, and a large amount of information useful to the practical man.

N. & G. Taylor Company, Philadelphia

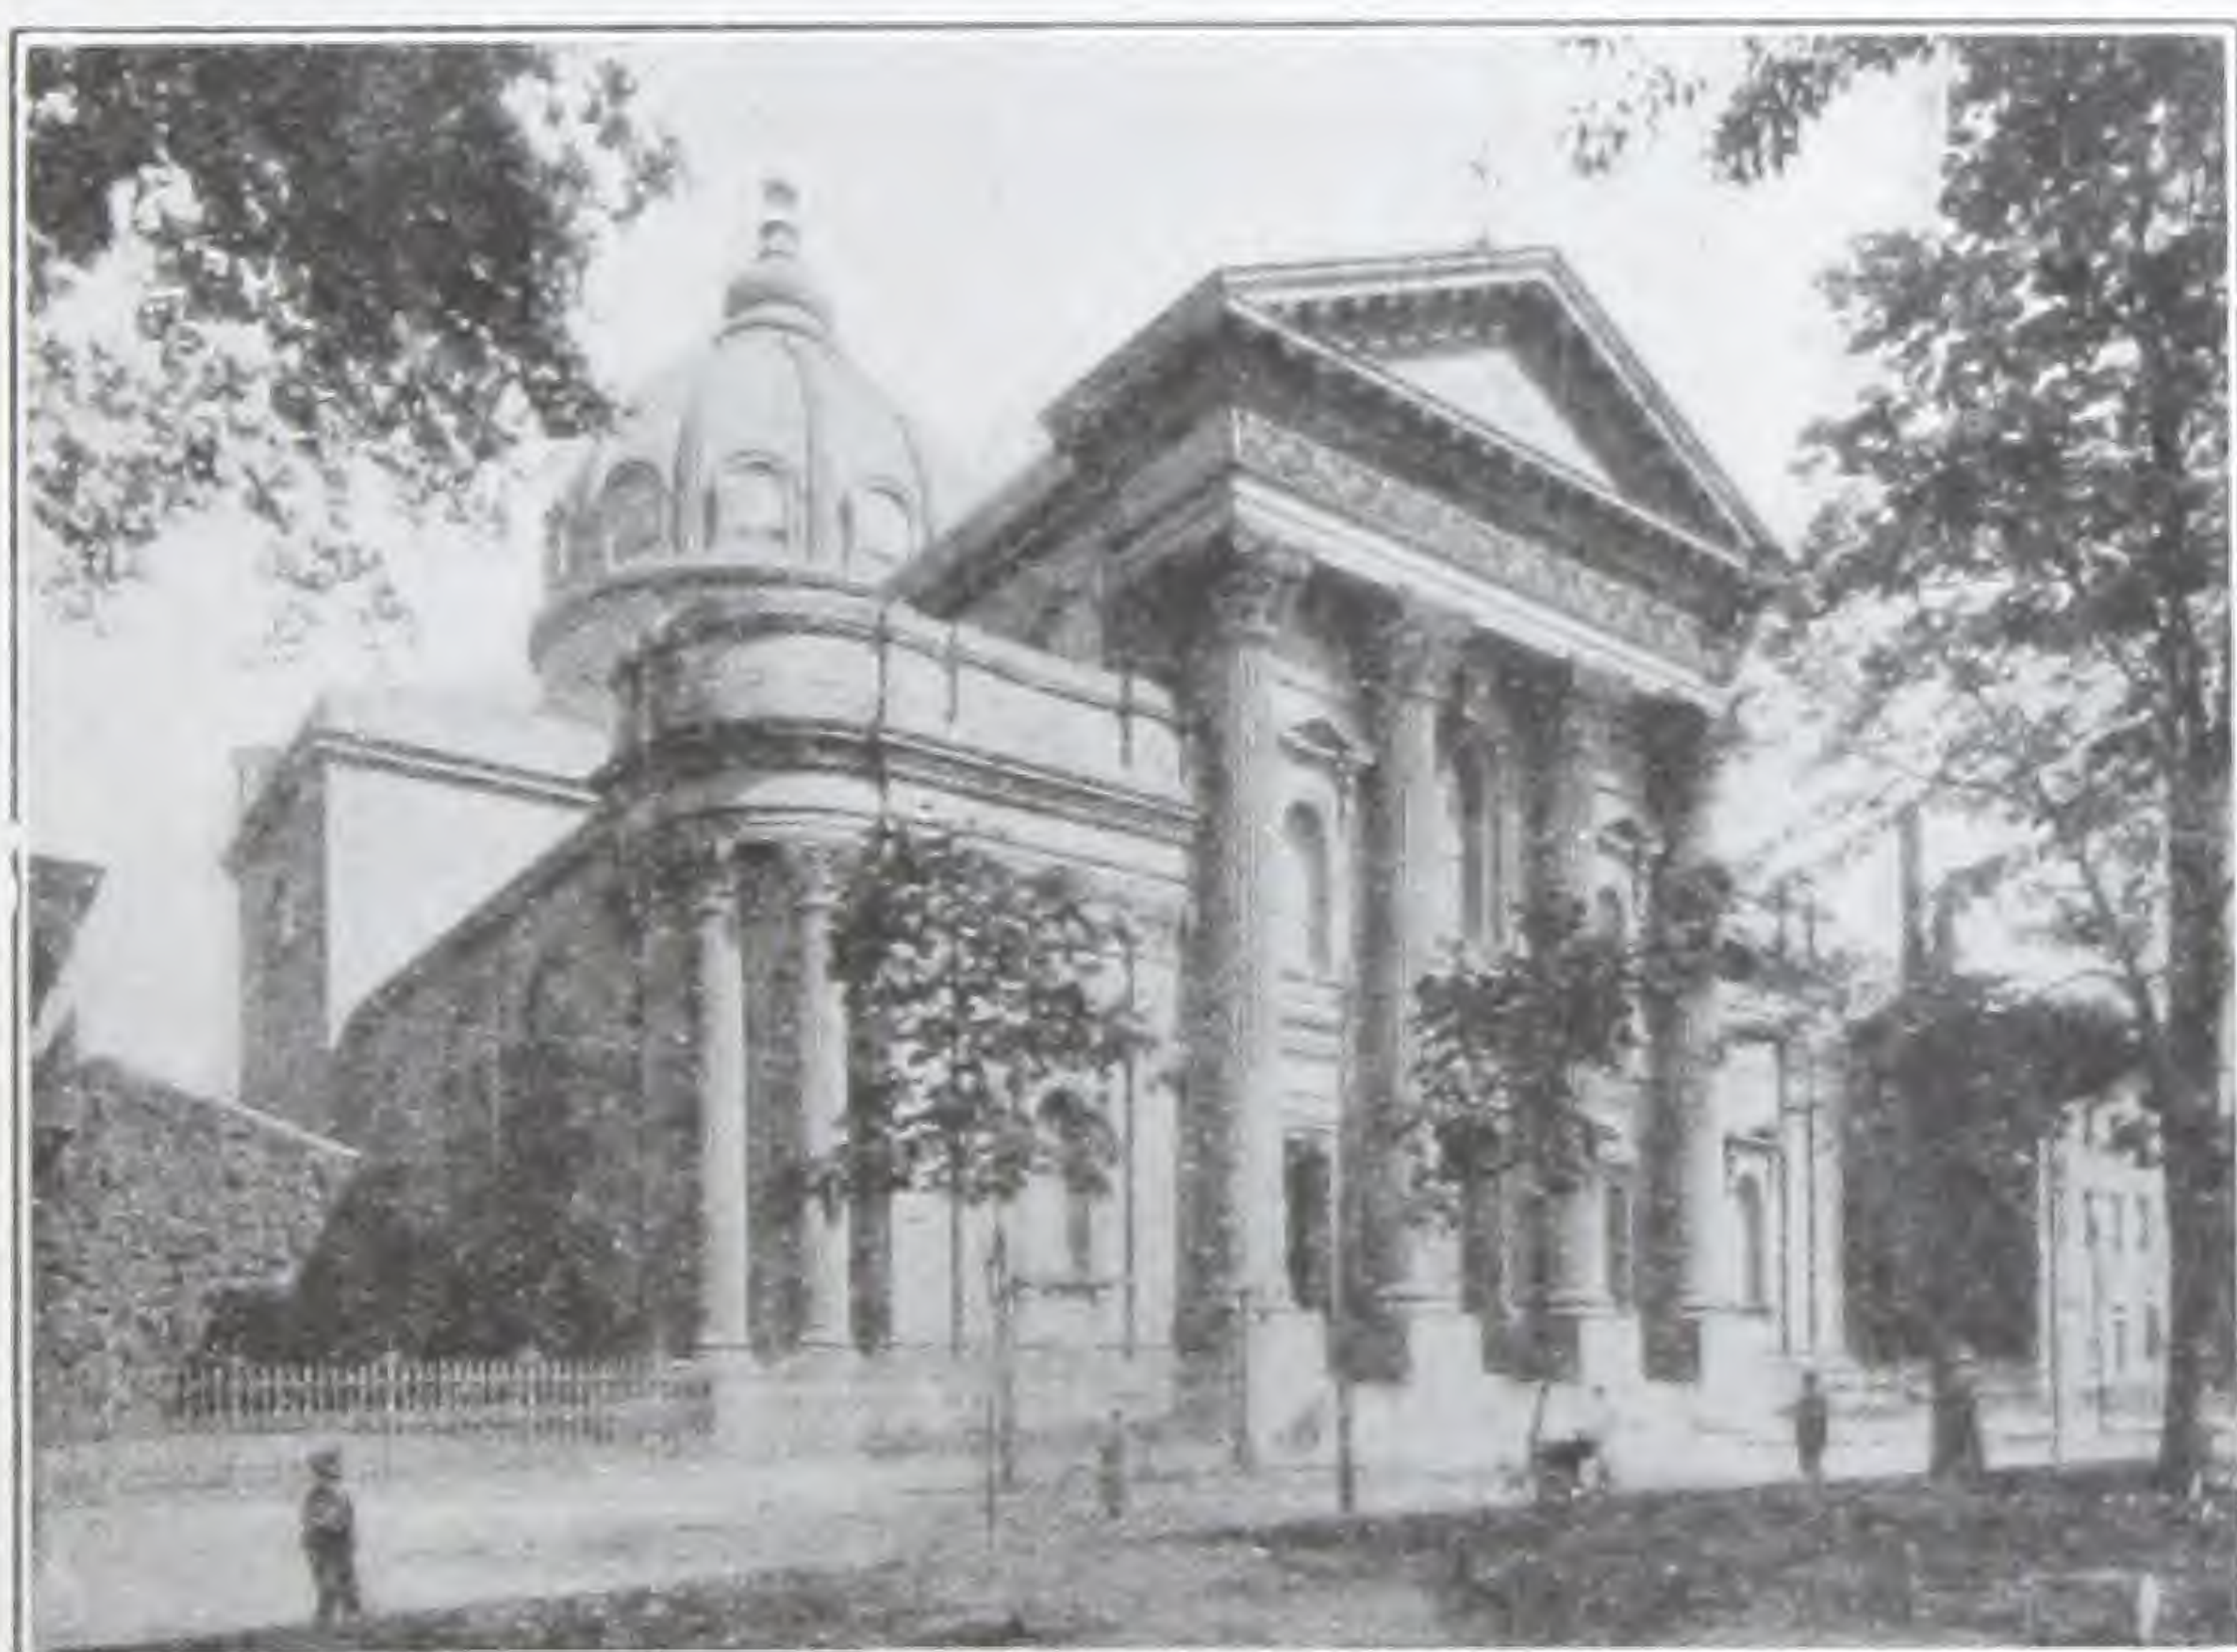
**1. DURABILITY:** In 1857—*54 years ago*—we furnished the tin used in roofing the dome of this structure—the Cathedral of St. Peter and St. Paul, Philadelphia. This tin has given satisfactory service, and is still in good condition.

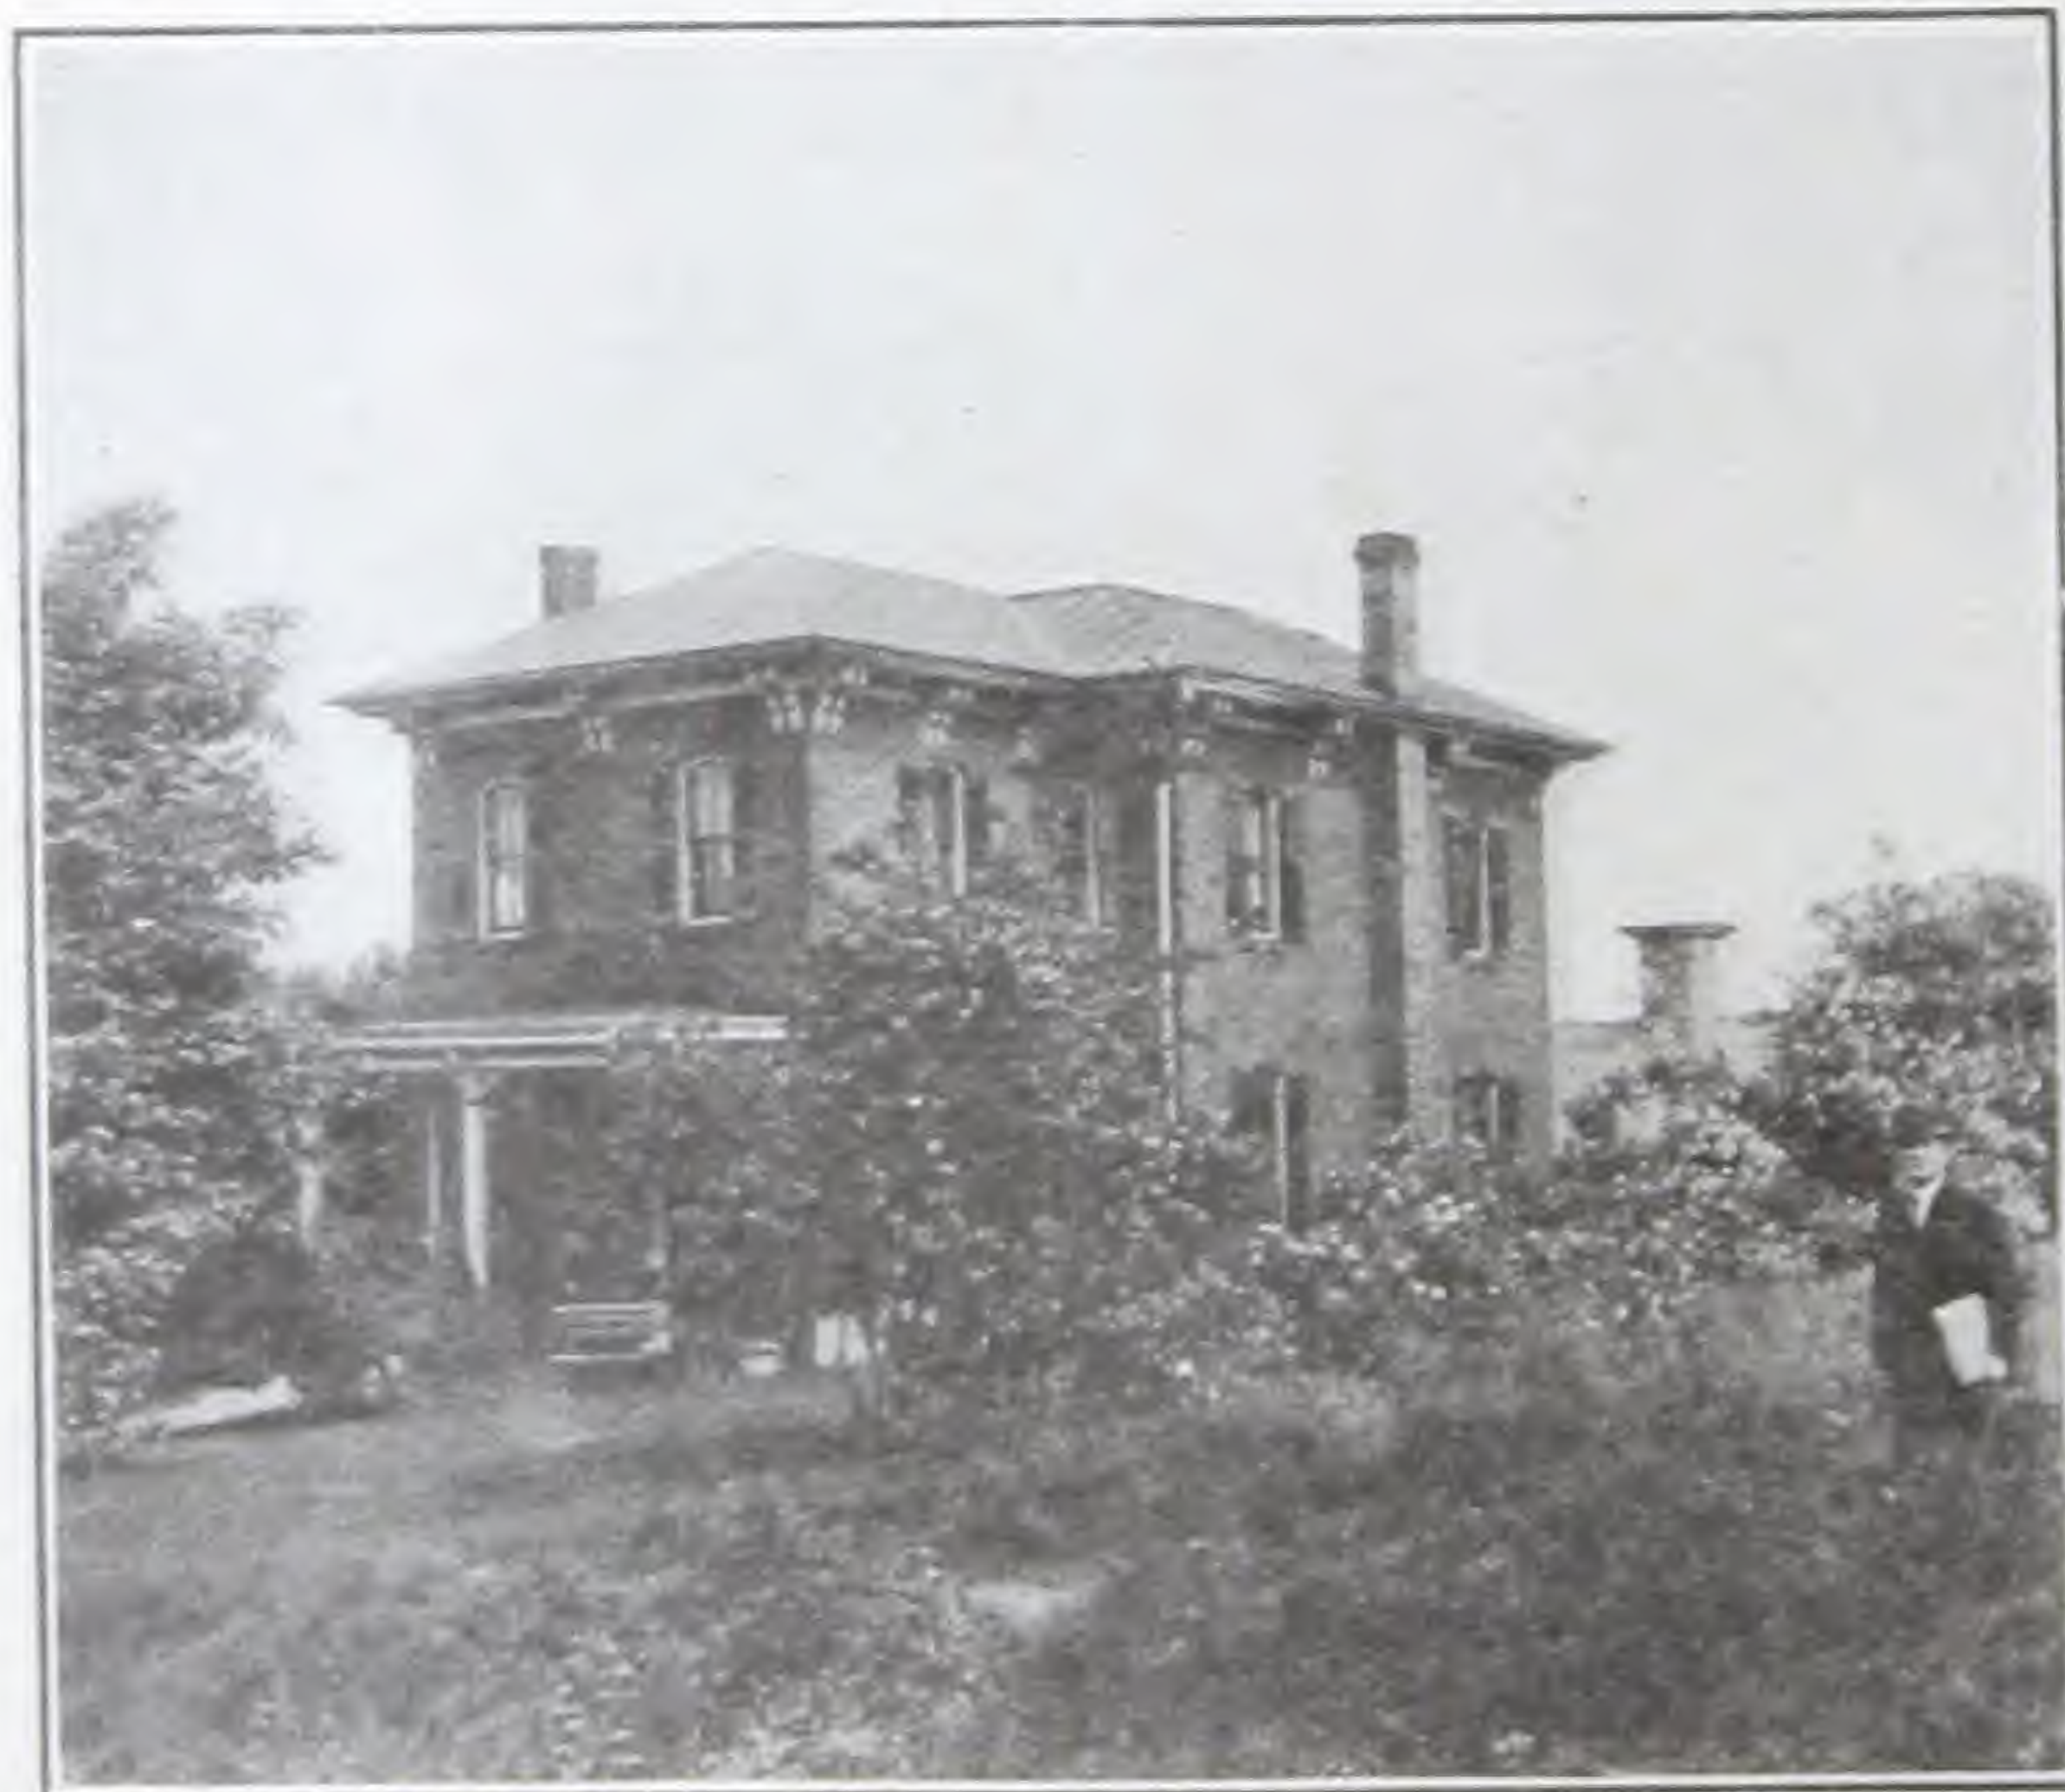
**2. DURABILITY:** This residence at Osnaburg, Ohio, was roofed with our tin in 1878. The roofer recently reported to us that all of this tin—the roof, downspouts, gutters, etc.—is in perfect condition.

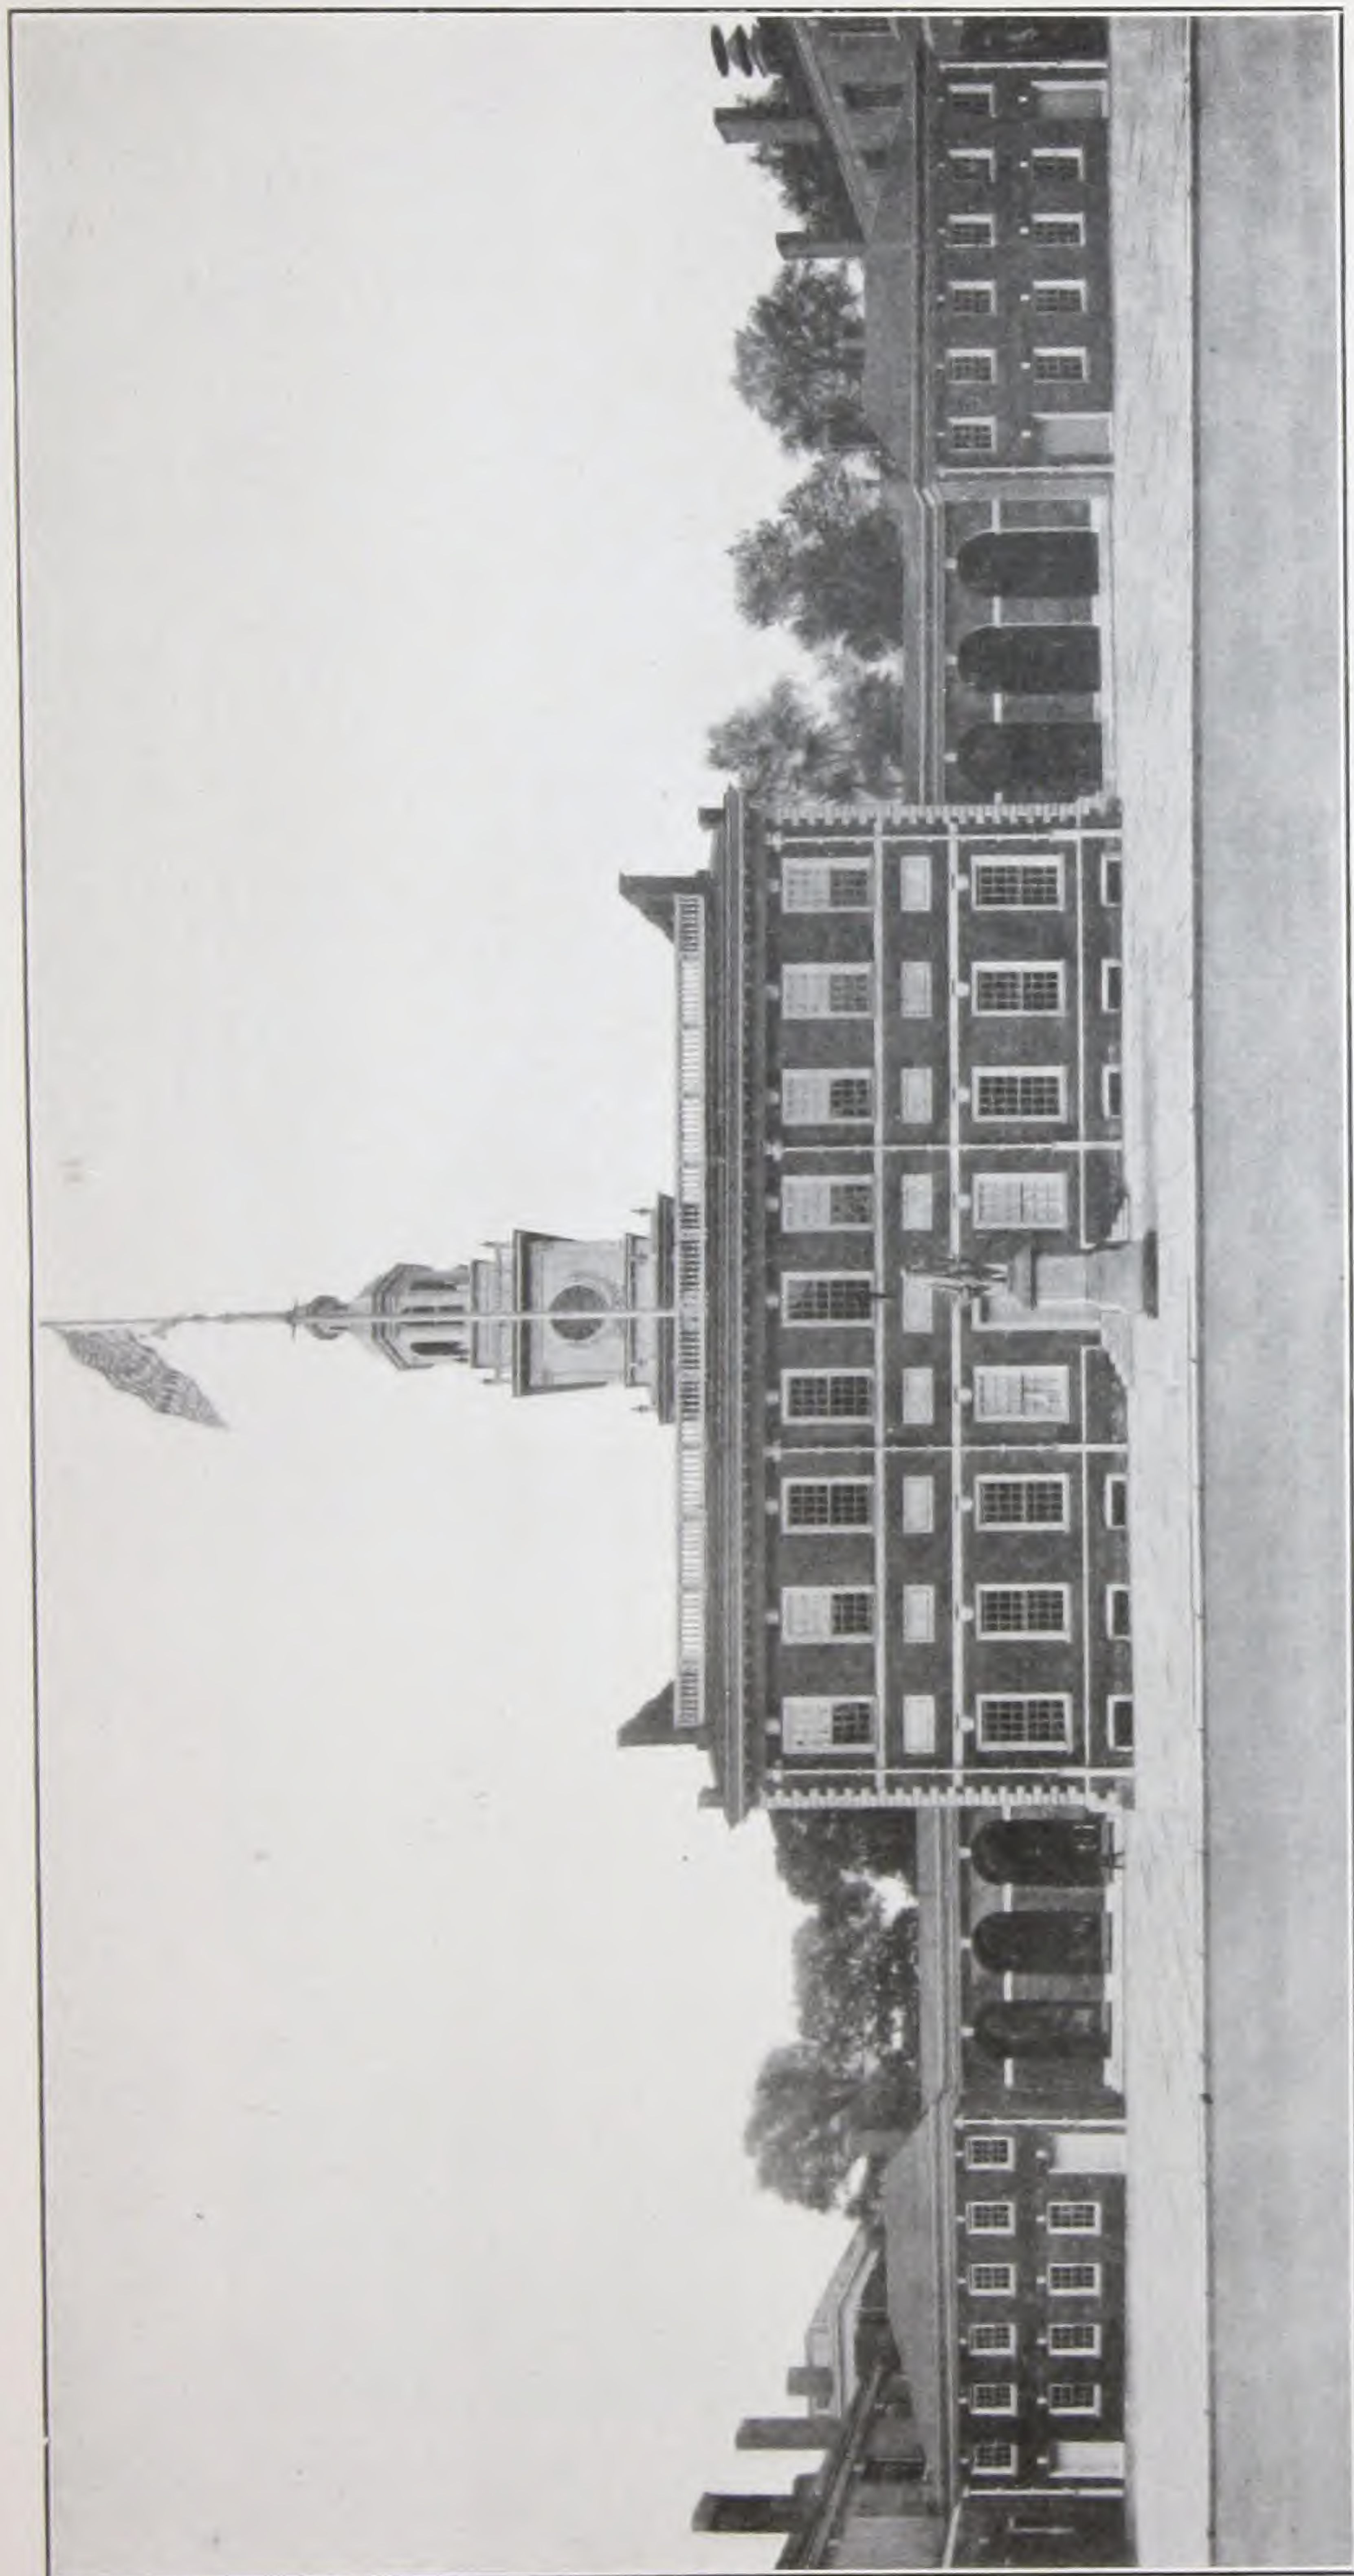
### OLD INDEPENDENCE HALL, PHILADELPHIA

This illustration shows the roof of our best tin covering the Nation's most treasured building, old Independence Hall, in Philadelphia, the Birthplace of Liberty. The main building of this venerable structure was originally covered with shingles, then with copper, which proved unsatisfactory, and finally, in 1887, with our heavily coated hand-made roofing-tin, the Target-and-Arrow brand. This tin roof has justified the choice of those who selected it years ago. Today, after 23 years' exposure to the elements, it stands in practically as good condition as when put on, and good for many years to come. A better proof of the value of the right kind of tin could not be shown. The home of the Liberty Bell affords an argument in favor of tin roofing that American sheet-metal roofers should present to any person who wants a first-class roof.

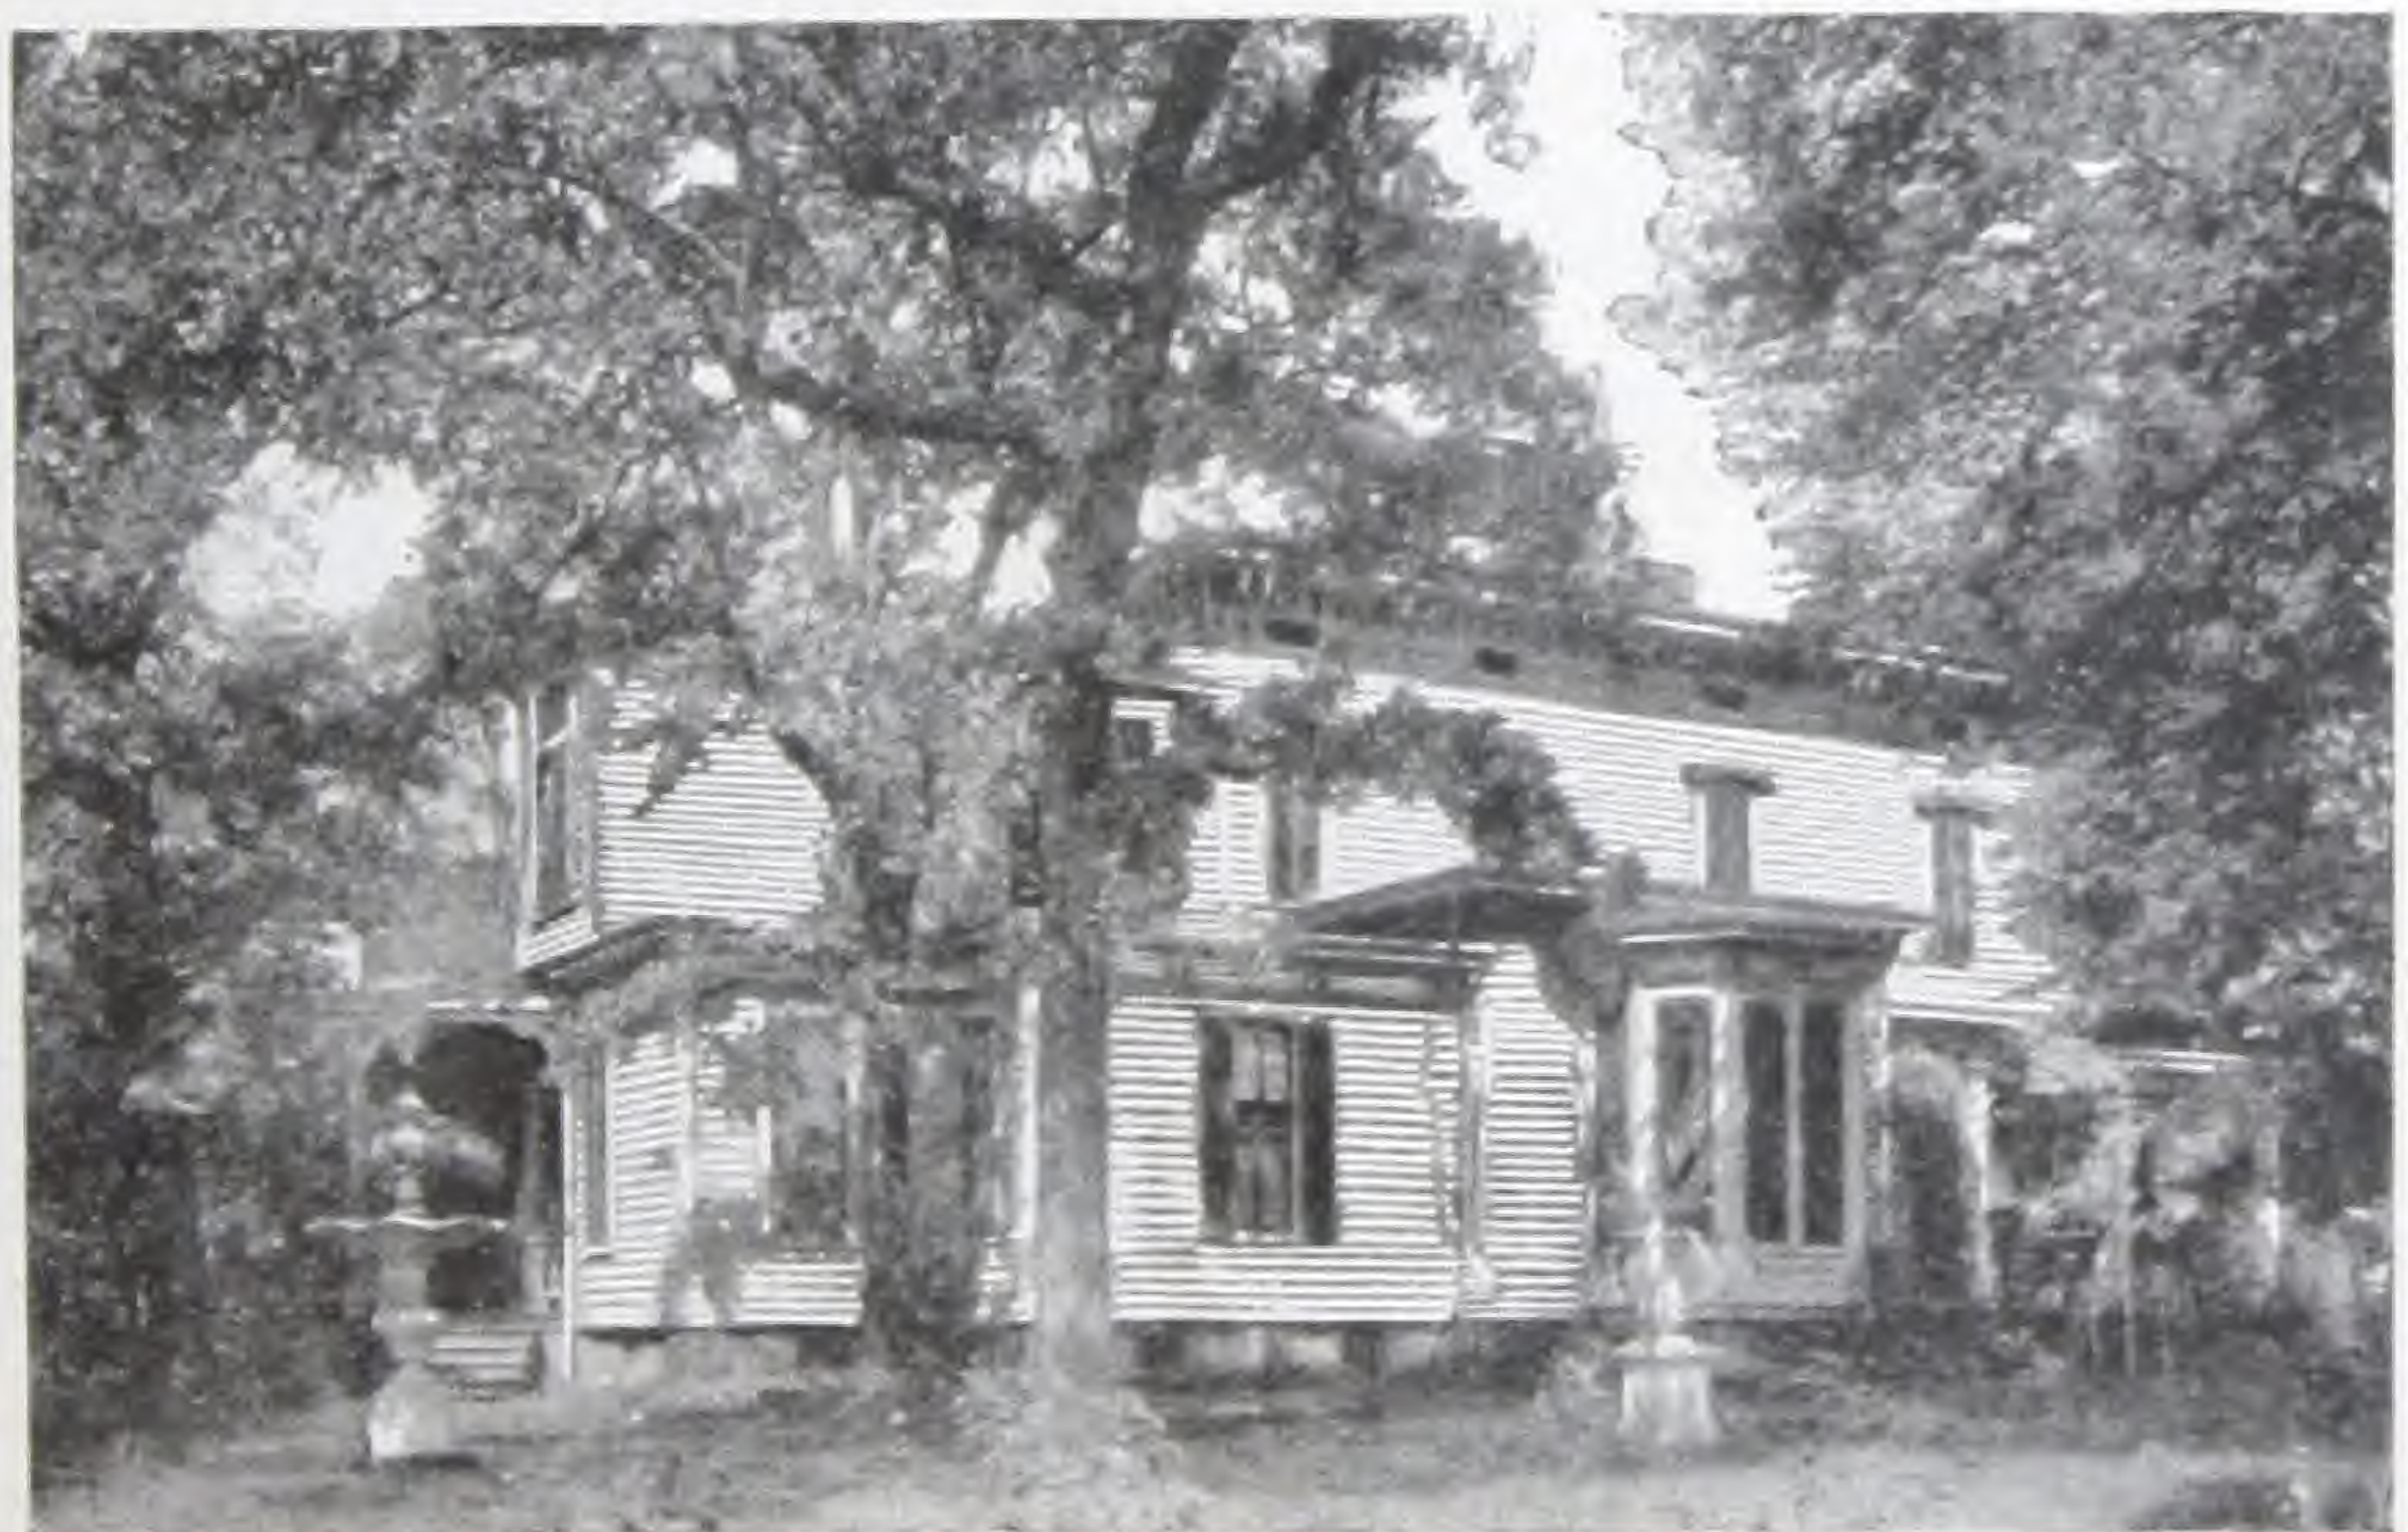
**3. DURABILITY:** The residence of Mr. George L. Baker, at Selma, Alabama, was roofed with our tin in 1859. Since then it has never sprung a leak or required repairs of any kind, and is in as good condition to-day as when first put on.

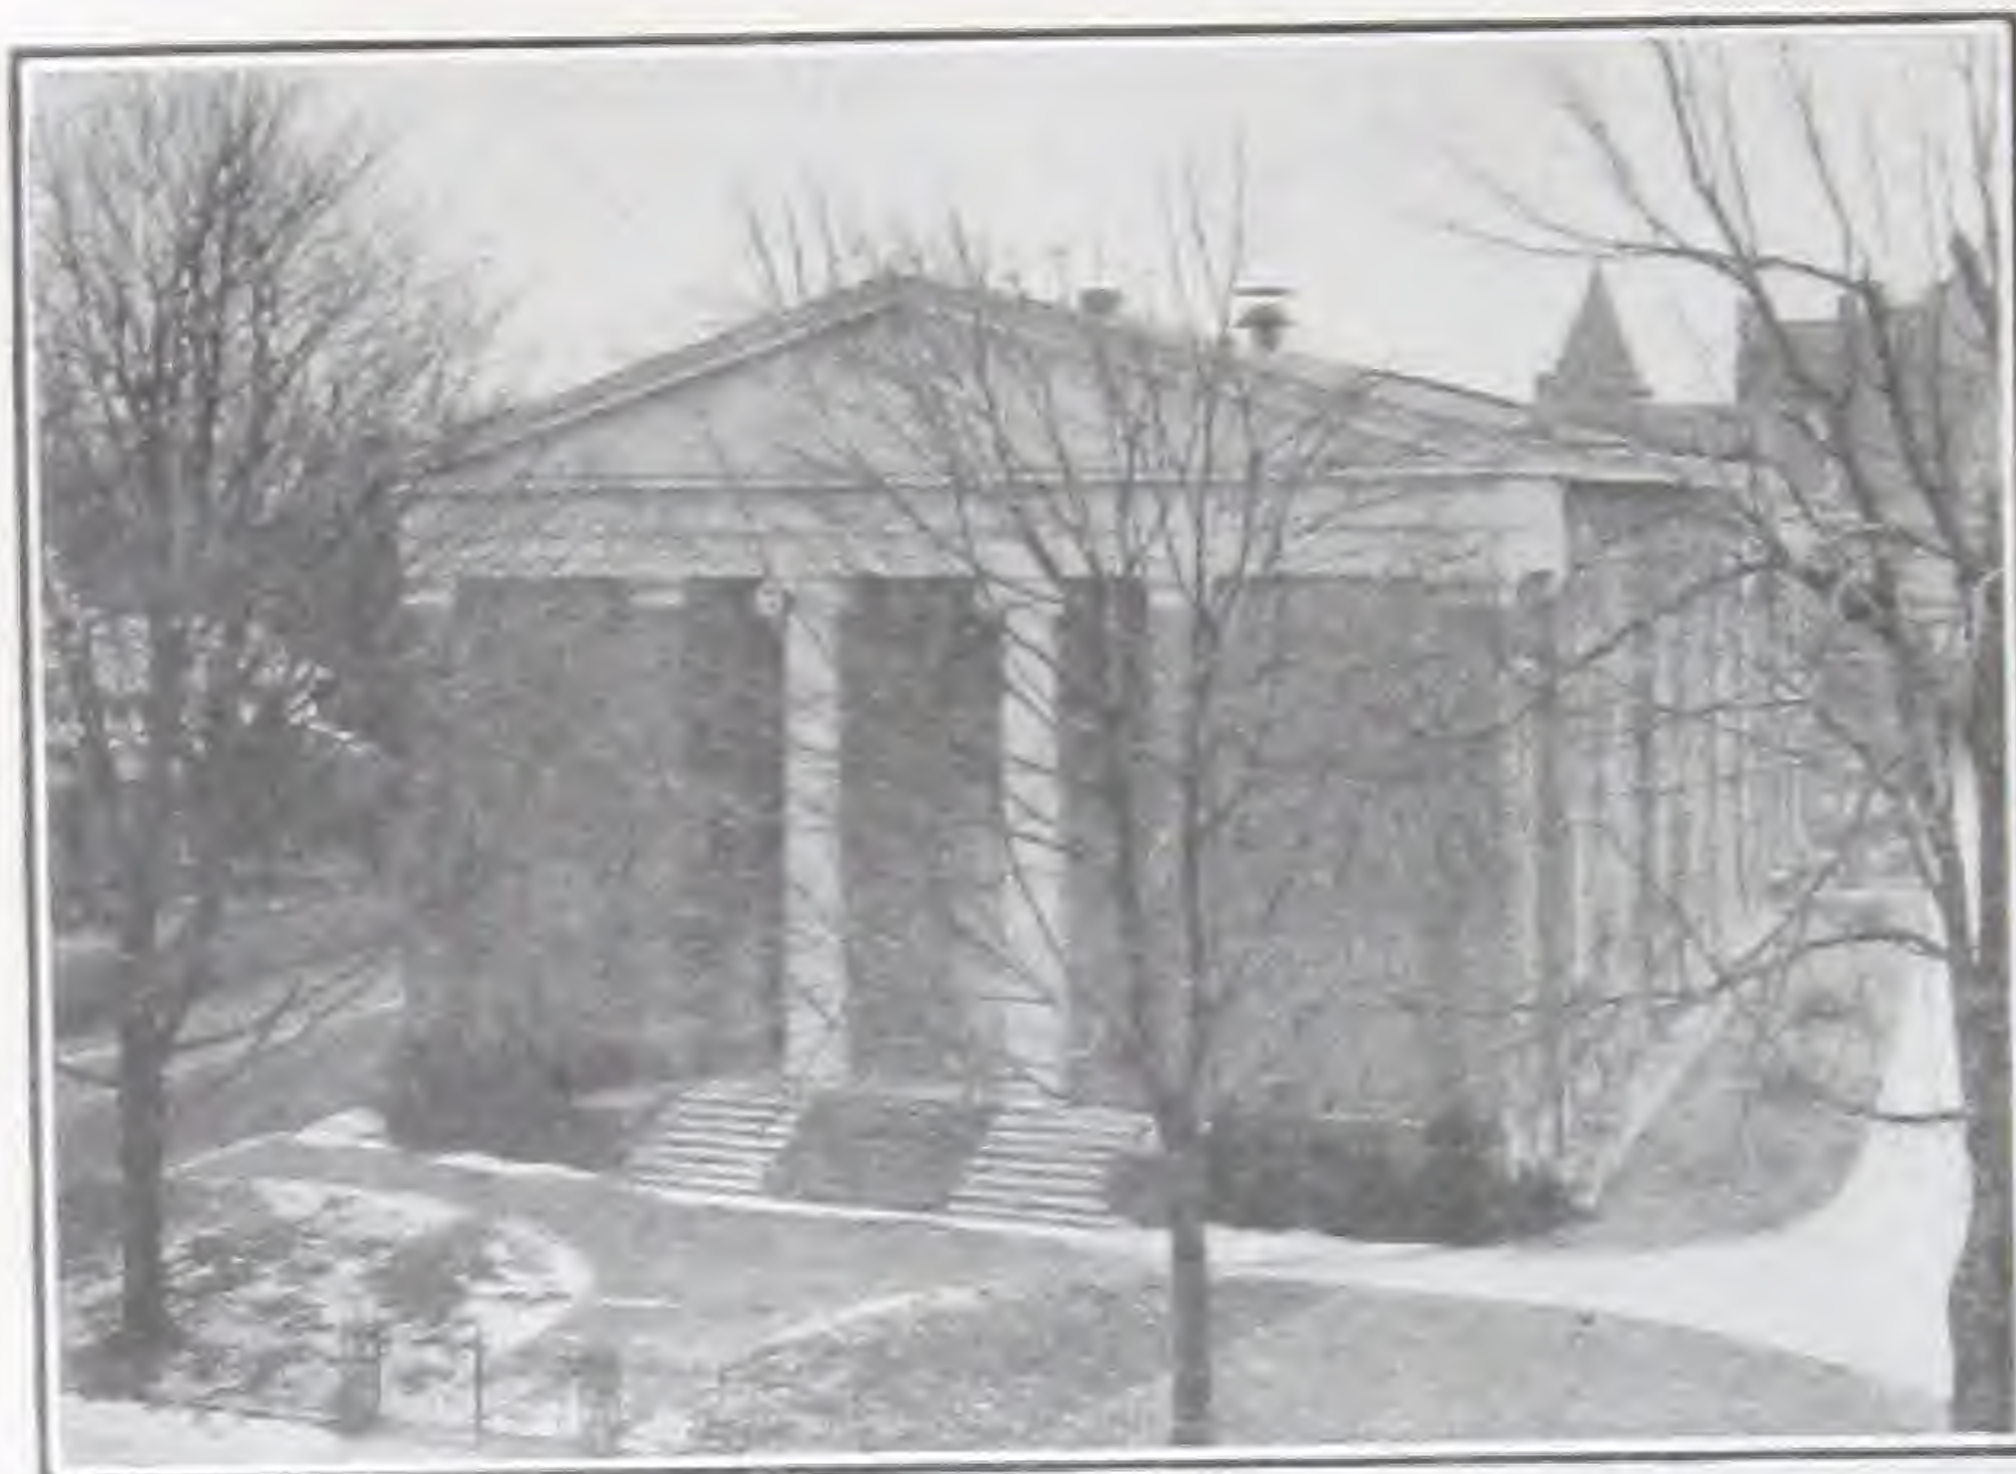
**4. DURABILITY:** First Presbyterian Church, Princeton, N. J. Roofed with tin more than sixty years ago, and in good condition to-day. Sheets 10" x 14" size, laid standing-seam. Painted with mineral paint and linseed oil. No repairs have been necessary except renewing the gutters.

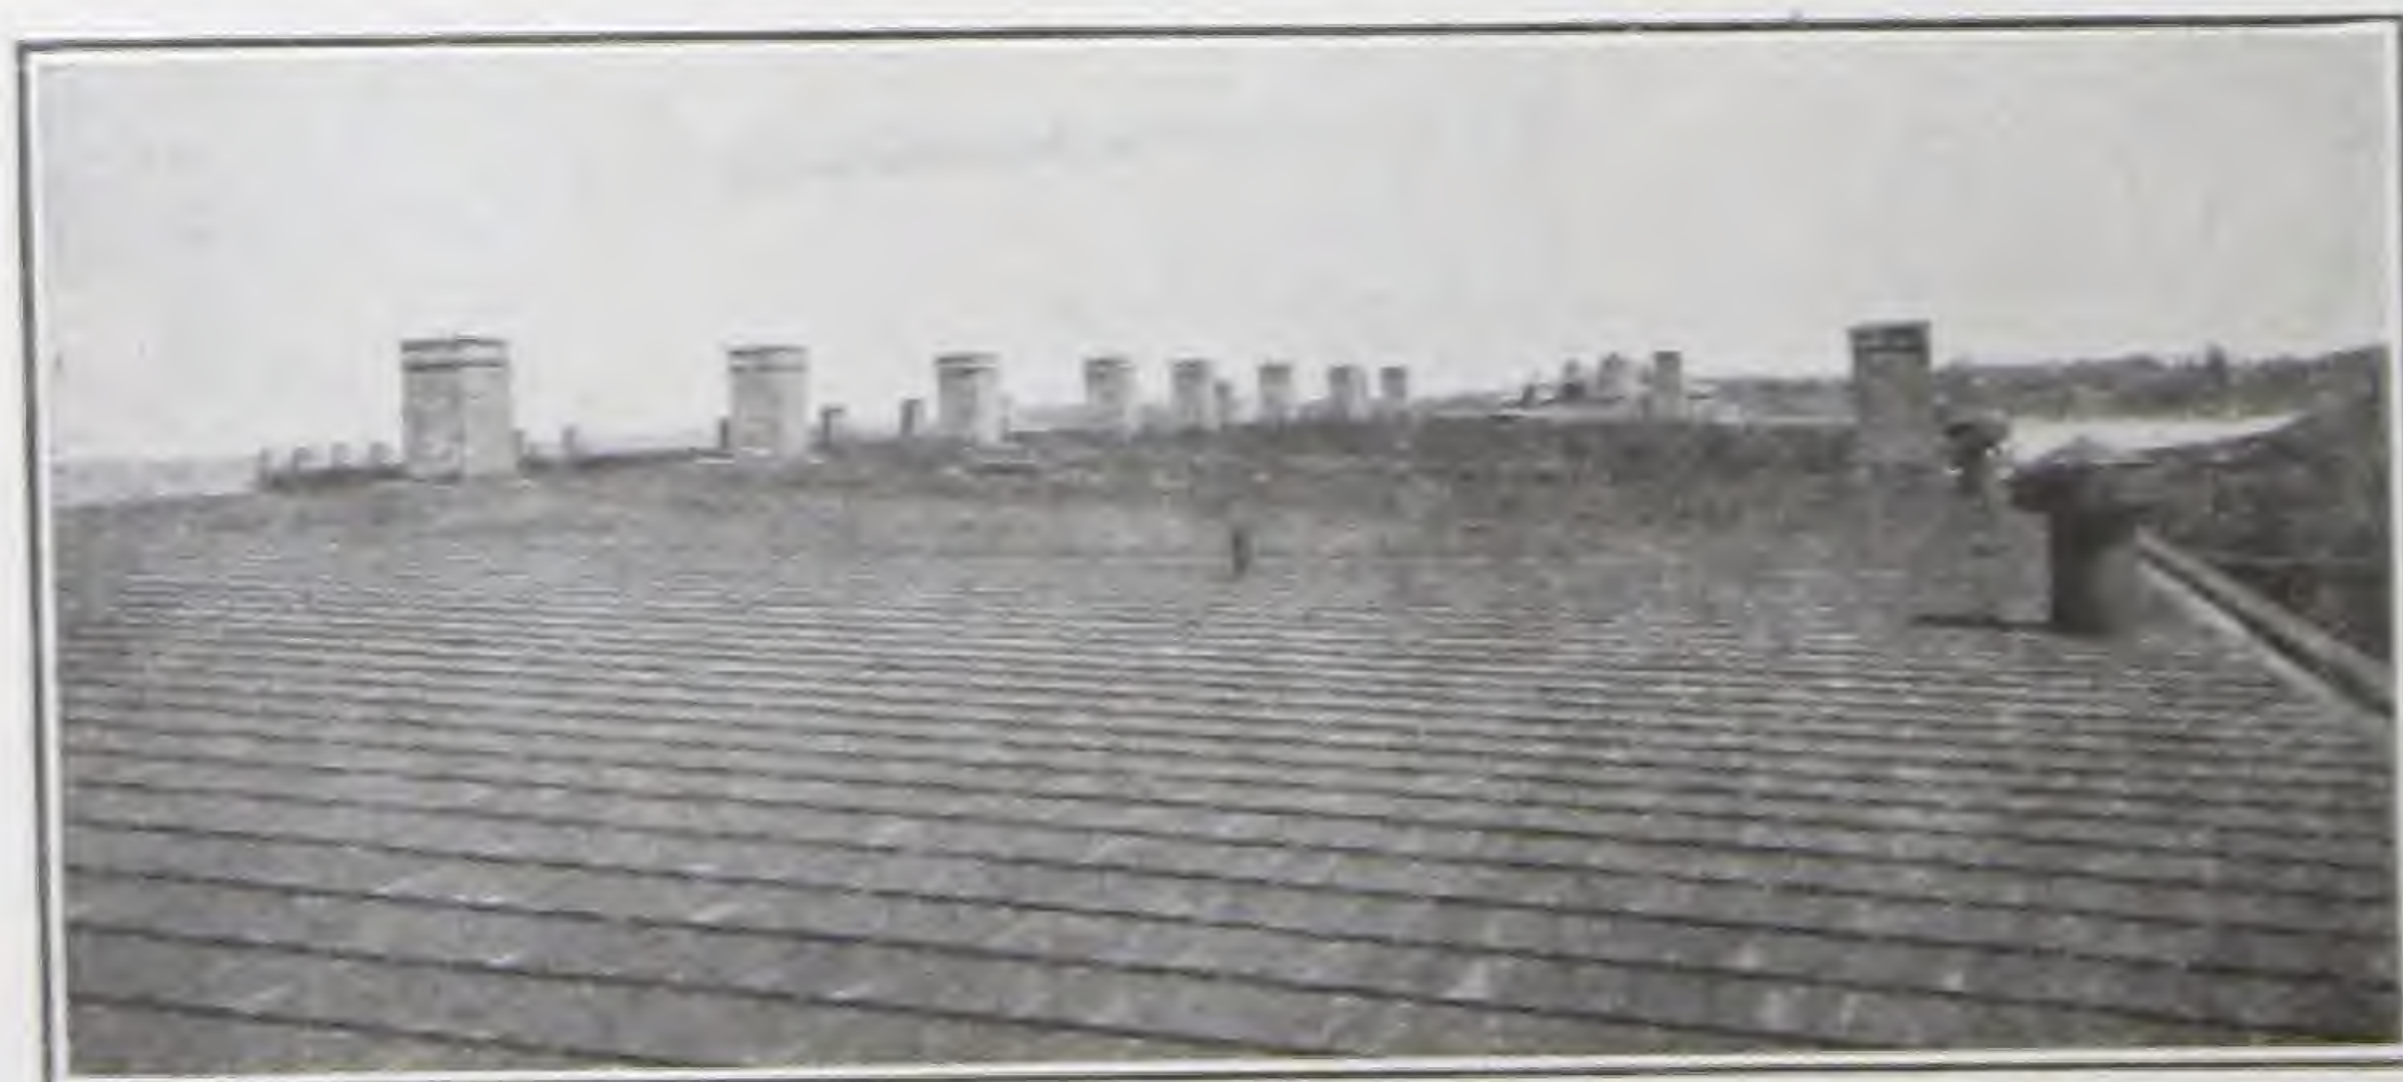
**6. DURABILITY:** The barracks at Fort Adams, Rhode Island, are all roofed with our tin, and furnish convincing proof of the durability of good tin along the seacoast.
